Search for charged particle emissions resulting from Pd-D Co-Deposition

Rick Cantwell & Matt McConnell Coolescence, LLC, Boulder CO USA

We have attempted to replicate Pd-D Co-Deposition charged particle results reported by Mosier-Boss et al. [1,2]. CR-39 pits similar to those reported by Mosier-Boss et al. were found using both in-situ CR-39 and Mylar-protected CR-39. However, CR-39 protected by a combination of Mylar and a small air gap did not show any pits. The electrolyte, as its chemistry changes during the electrolysis, is shown to damage the acrylic cell containing the experiment and to damage an aluminum foil separated from the electrolyte by a Mylar film. This damage together with the absence of pits when a small air gap is added to the Mylar protection suggests chemical reactions may be the source of the observed CR-39 pits.

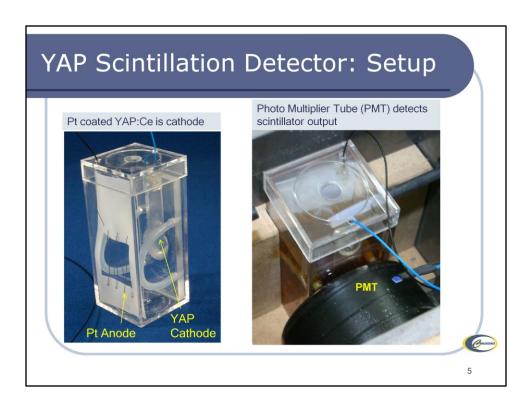
Pt thin-film is evaporated onto YAP to make cathode.

The back side of YAP is optically coupled to a photo multiplier tube to detect scintillation output.

We calibrated with a Po-210 source before adding electrolyte.

During electrolysis, Pd is co-deposited onto the surface of YAP.

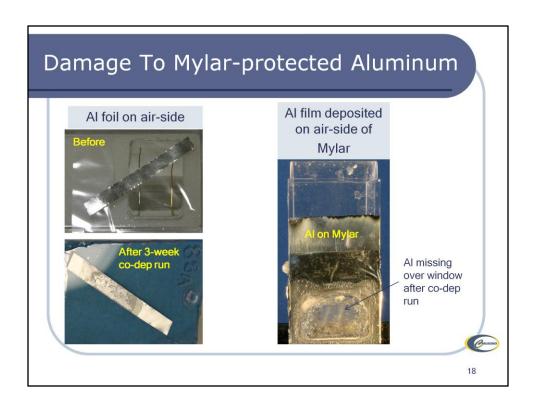
Does the electrolyte damage Al on outside of Mylar? Yes – both strip and Al evaporated onto Mylar

This test suggested by David Kidwell (NRL). Does electrolyte damage CR-39?
